ACCIDENTAL RADIATION EXCURSION AT THE OAK RIDGE Y-12 PLANT  
PART II - HEALTH PHYSICS ASPECTS OF THE ACCIDENT

J. D. McLendon

November, 1958

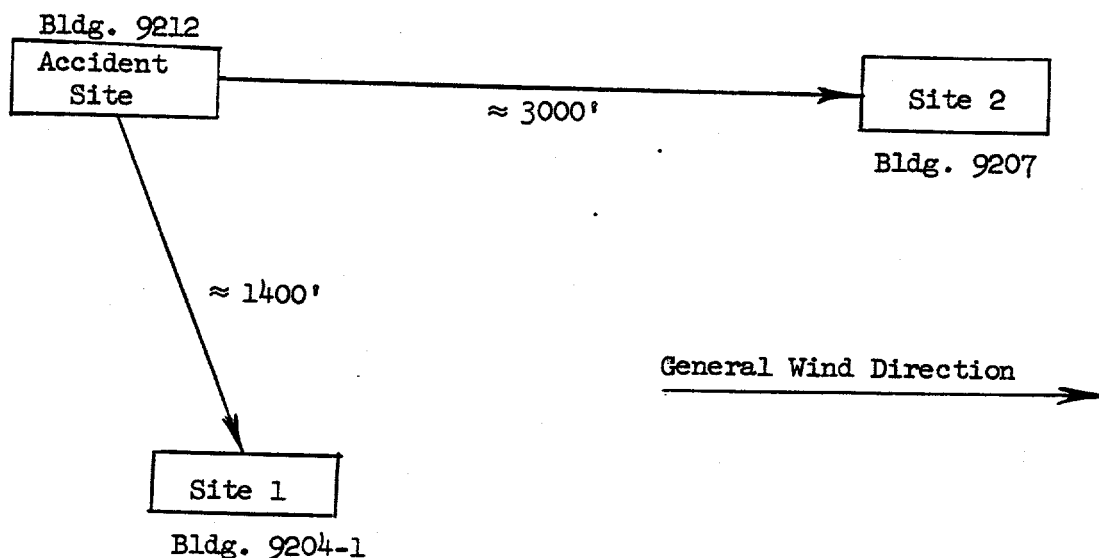
Some indication of air-borne contamination released to the atmosphere may be obtained from inspection of two continuously recording beta-gamma air monitors which were located as shown in the sketch below. These monitors are Geiger-Muller tube instruments measuring and recording the beta-gamma emission from particulates collected from an air stream on a fixed filter paper. The tubes are surrounded by the filter and are shielded by 1-1/2 inches of lead.

1. The level of initial direct radiation recorded at Site 1 was higher than that observed at Site 2 because of the distances involved.
2. The air-borne contamination, however, reached Site 2 much sooner (10 minutes vs  $\approx 45$  minutes) and in higher concentrations (considerably more than a factor of three), since it was directly downwind.
3. Because of the short half-lives of the fission products,  $< 2$  hours, and the relatively short length of exposure of any persons to the contaminated atmosphere, the concentrations detected constituted no acute hazard.
4. Considering the favorable conditions of wind velocity and direction existing at the time and the levels of concentration detected, it can be stated, with a high degree of confidence, that no significant concentrations of these activities reached any nearby populated areas.

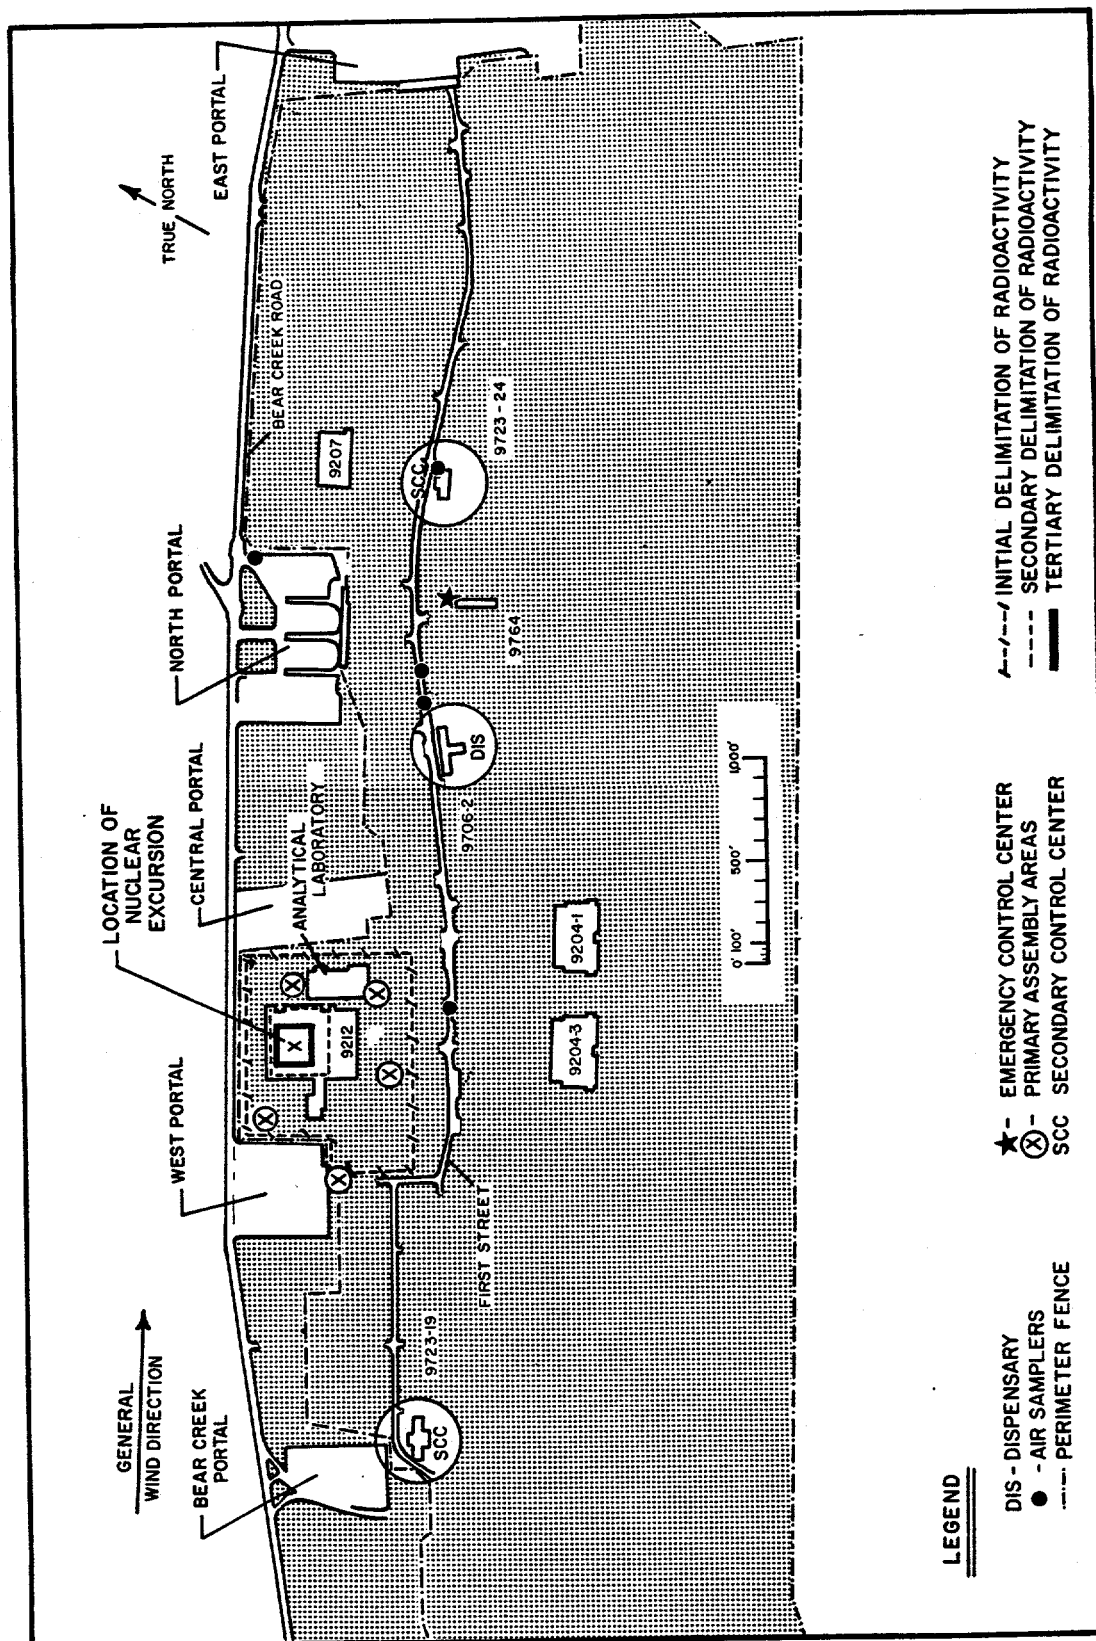
Figure 1  
LOCATION OF Y-12 PLANT BUILDINGS PERTINENT TO INCIDENT

Within an hour and a half after the excursion, teams of health physicists began approximating the site of the incident by a series of perimeter radiation surveys. The radiation and contamination levels encountered were quite low, ranging from 0.2 mr/hr at the boundary of the primary delimitation area to 10 mr/hr at distances of approximately 200 feet from the drum. Although some spillage of materials had occurred in a few areas due to unattended operating equipment, no serious contamination levels were encountered. Boundary limits were adjusted to permit employees to re-enter all areas except those within the secondary delimitation boundary ( $\approx 350' \times 400'$ ) shown in Figure 1.

Some three hours after the incident, an emergency team undertook a cursory survey of the salvage area itself in which the reaction had occurred. The radiation dosage rate at the southwest door of this area, a distance of approximately 100 feet from the drum, was 60 mr/hr. When the men emerged, after being in this location for about ten minutes, the canisters of their gas masks read from 10 to 15 mr/hr, indicating that significant concentrations of air-borne contamination still existed in the area. Radiation measurements, direct and by air-sampling, were continued in the zone proximate to the accident area. Within a few hours, it was possible to relax the restriction boundaries to that area indicated as the tertiary delimitation area in Figure 1.

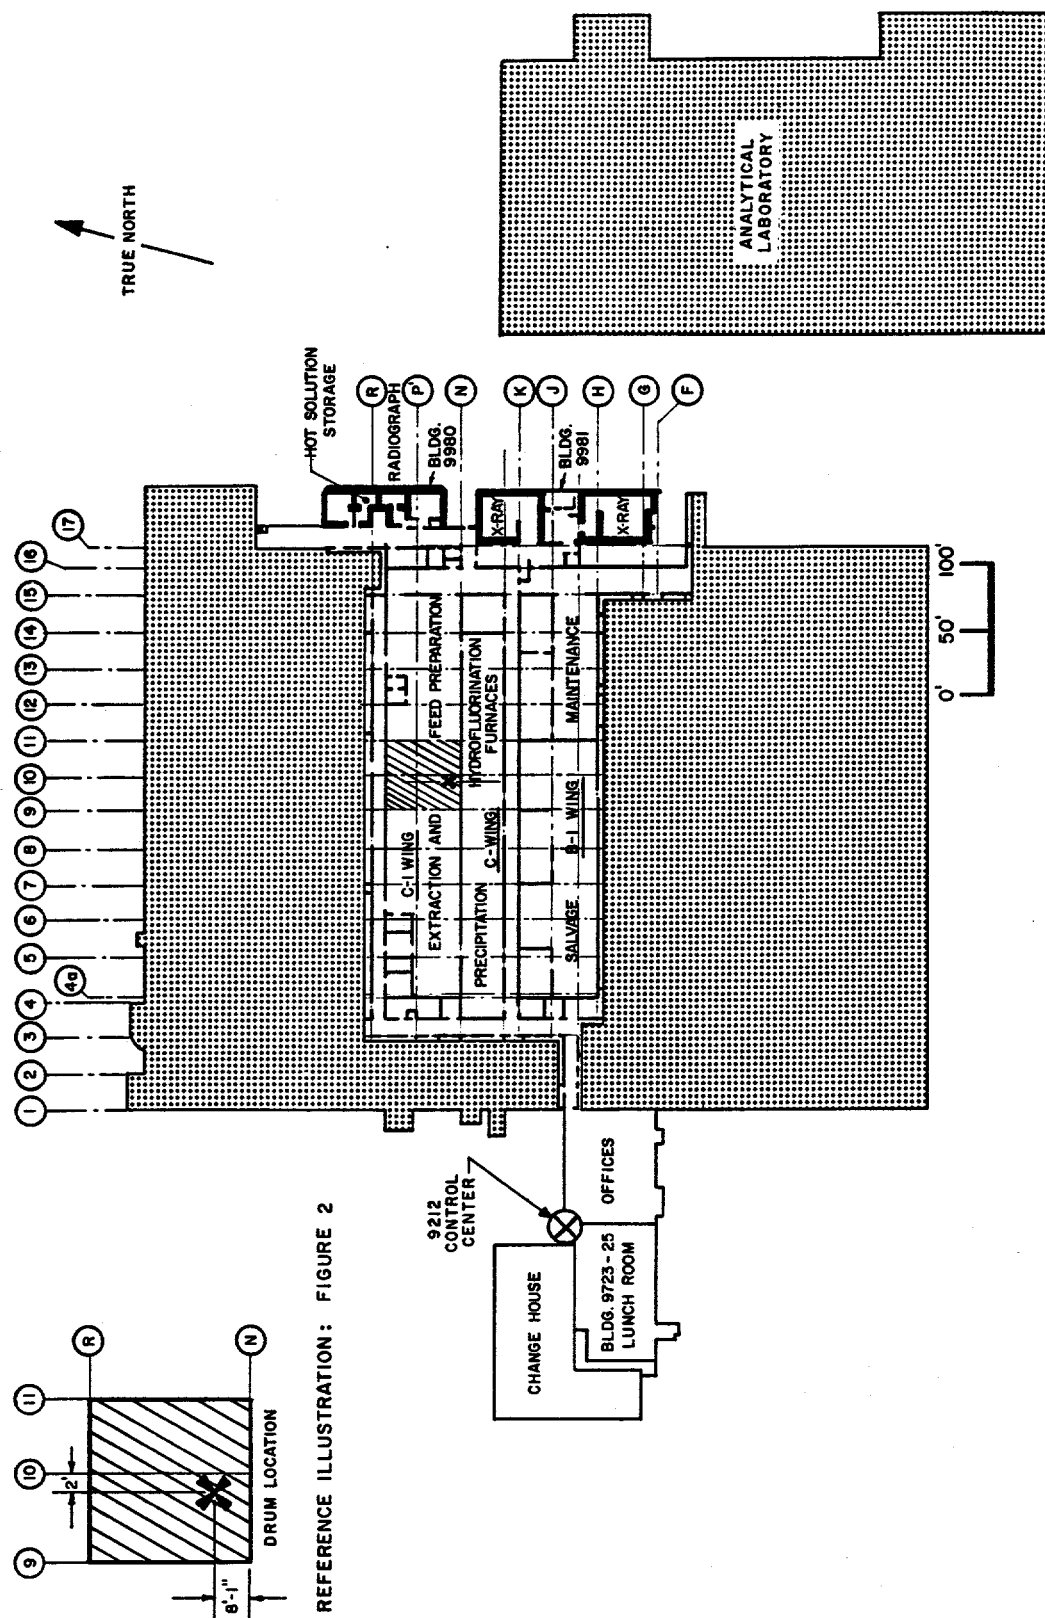
Figure 2  
LOCATION OF NUCLEAR EXCURSION  
Building 9212

At approximately 2:05 p.m., June 16, 1958, sirens of the radiation monitoring system sounded the alarm in Building 9212, implementing the building evacuation plan. Immediately, process supervisors, equipped with emergency radiation survey meters detected, and confirmed by multiple readings, radiation intensities of more than 100 mr/hr at the building control center, a distance shown later to be about 350 feet from the location of the accident. The Plant Emergency Director, who was present at the time of the alarm, acted to put the plant emergency plan into effect, thus evacuation of personnel from primary

assembly points to secondary control centers proceeded with little further delay. See Figures 1 and 2 for locations.

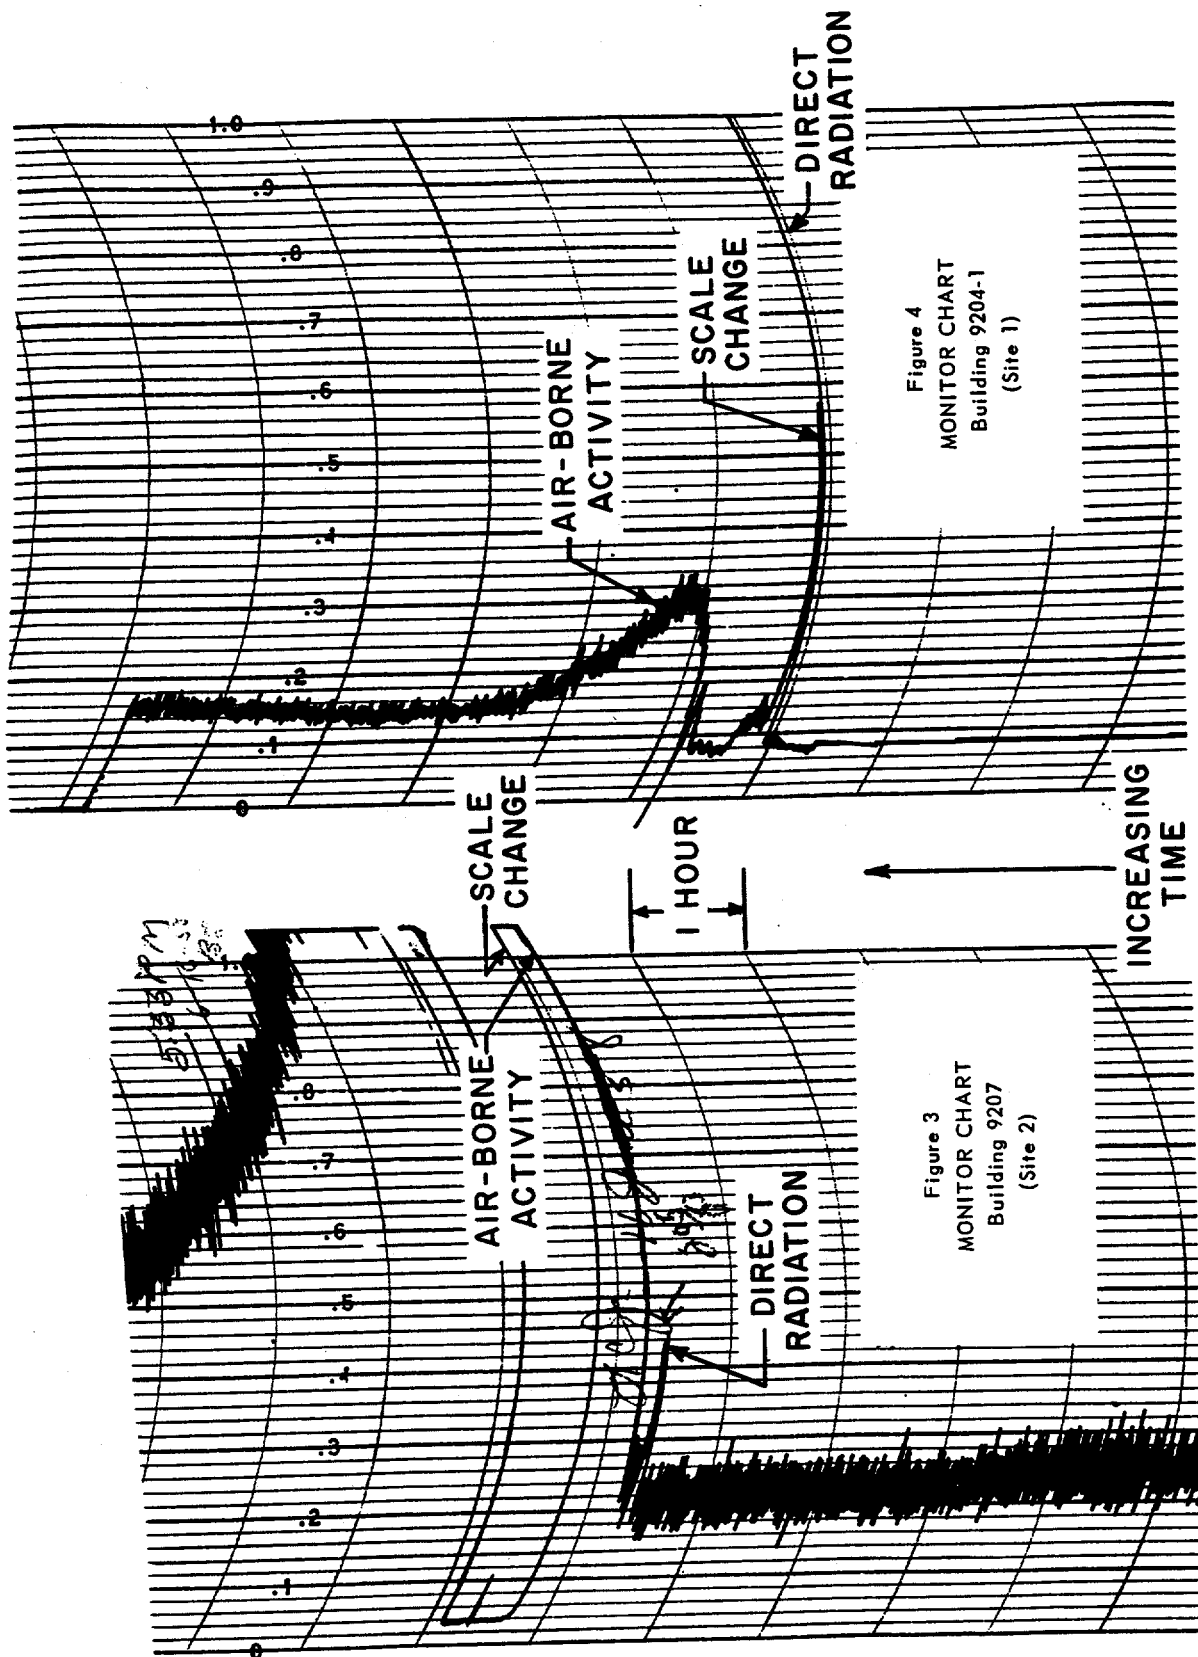
Both instruments detected the initial direct gamma radiation from the actual excursion and both showed subsequent increases in the level of atmospheric beta-gamma contamination. The following observations are made from inspection of the charts from these instruments. See Figures 3 and 4.
